**INSTRUCTIONS FOR TRANSPORTATION,  
HANDLING, STORAGE OF THE DRUMS AND  
LAYING OF THE CABLES**

**INSTRUCTIONS FOR TRANSPORTATION,  
HANDLING, STORAGE OF THE DRUMS AND LAYING  
OF THE CABLES**

<b>Revision:</b>	00		
<b>Date:</b>	Sept 2014		
<b>Written By</b>	Hilary Marazzato		
<b>Checked By</b>	Selim Yetkin		
<b>Approved By</b>	Bernard Albouy

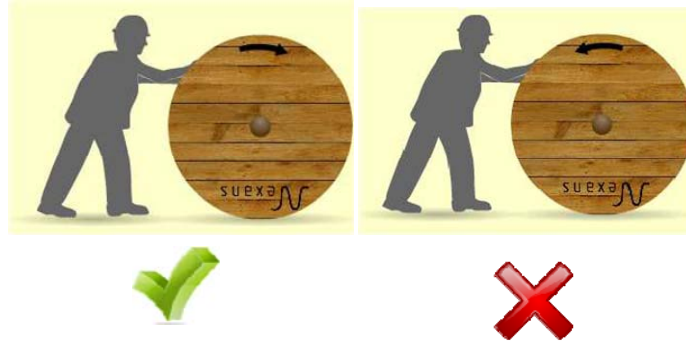
Drum flanges are marked to provide vital information to assist with the handling of the drums and the installation of the cable. This information includes drum weight, a mark on the flange indicating the end of the cable, and an arrow indicating the direction the drum is to be rolled during rolling or transportation.

The rolling of the drum in the direction of the arrow ensures that there is no tendency for the cable to loosen its wind on the drum. It should be noted that when pulling the cable off the drum and installing the cable, the arrow will point in the opposite direction to the rotation of the drum.

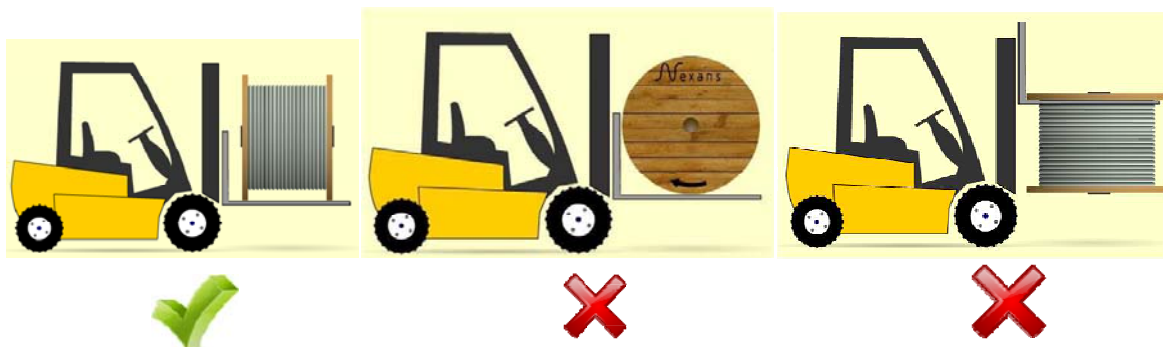
In general, the forklift truck method of drum handling is only applicable where a hard and level ground surface is available. This is required in the intended storage area. In this case a forklift capable of lifting about 12 tonnes will be required (maximum drum weight plus contingency). It is also necessary to ensure that the forklift truck tines are capable of traversing the width of the drum and provide support to both flanges.

For the smaller drums, tines of 1200 mm length will be satisfactory. The larger drums will require tines of 1800 mm length. For the larger drums, for example containing 33 kV or 132 kV cables or long lengths of cable, it will be necessary to have tines at least 2500 mm so that the cable drums are adequately supported by both drum flanges.

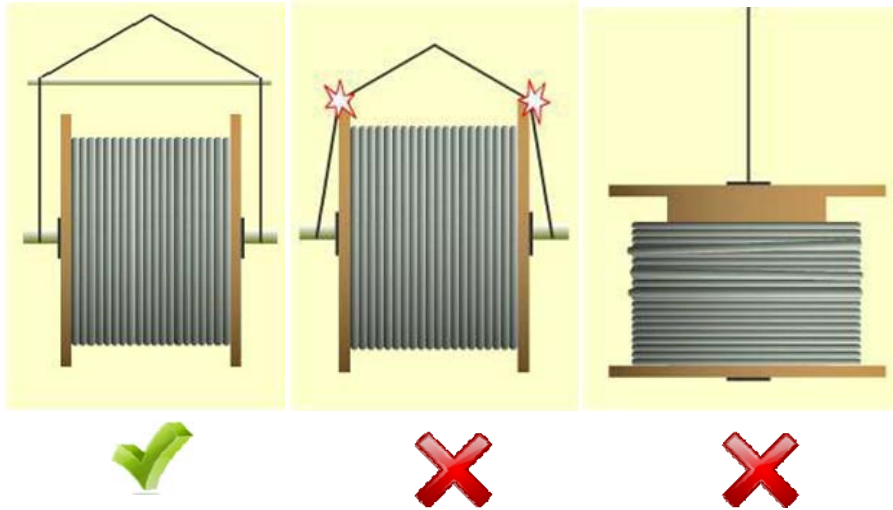
Some drums may be of sufficient length and weight to require cranes to load and unload from transport vehicles. In this case, it will be necessary to ensure that a spreader bar of sufficient length is used to ensure the lifting chains do not compress the drum flanges.

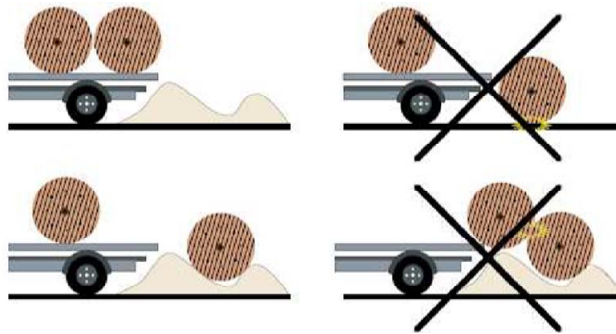
When forklift or crane is not available, a makeshift ramp with approximate inclination of 1:4 should be constructed. The cable drum should then be rolled over this ramp by means of ropes or winches. Additionally, a sand bed at the foot of the ramp can be build to brake the rolling cable drum.

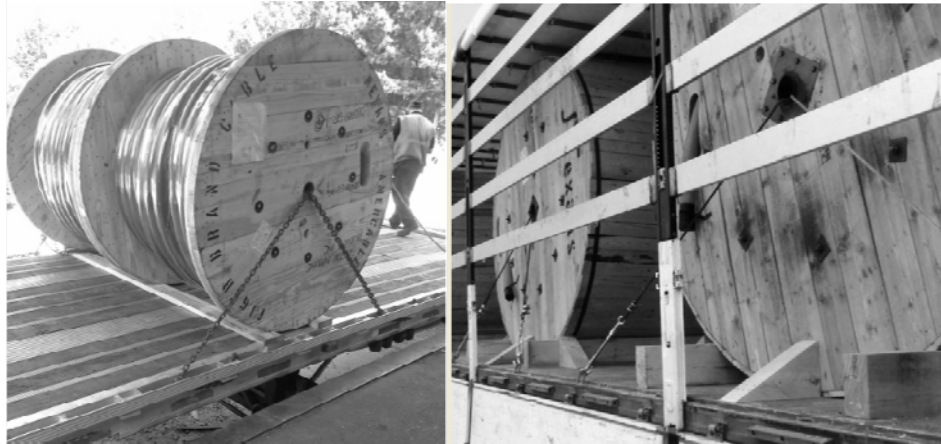
When the drums loaded on trucks are larger than 250cm, binding must be made with ropes crossing through the central hole and if necessary on the drum flanges.

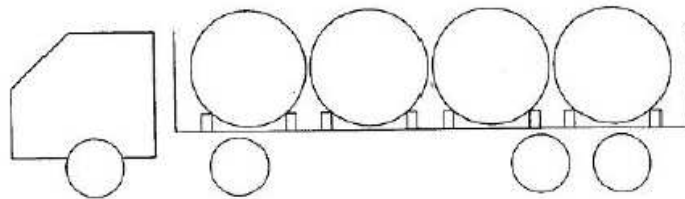
### "Bore perpendicular" chocking

The drums are placed parallel to the lorry axis

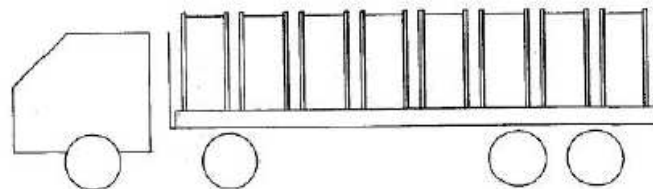
### "Bore parallel" chocking

The drums are placed perpendicular to the lorry axis

Provided that the diameter of the drums is less than the width of the lorry, they can be loaded " bore parallel chocking "

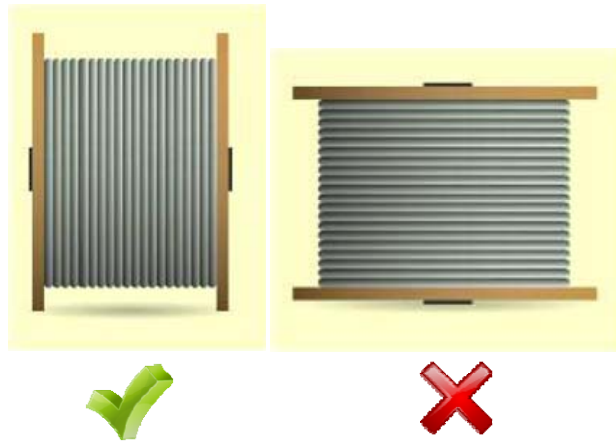
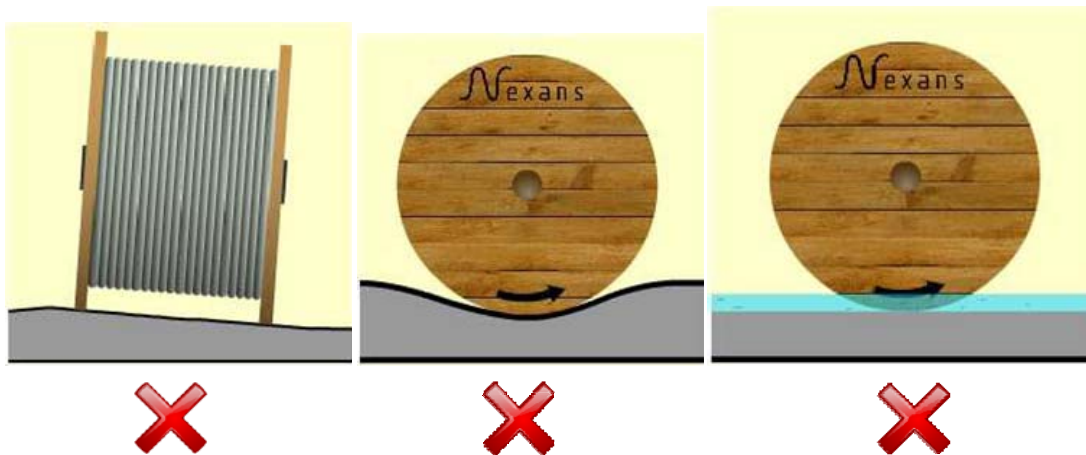
Drums should be stored on a level and firm surface (e.g. timber baulks, firm gravel, or concrete), on the flange edges (not with the flange flat on the ground), such that they will not be standing in water or in continually damp conditions, and restricted from rolling.

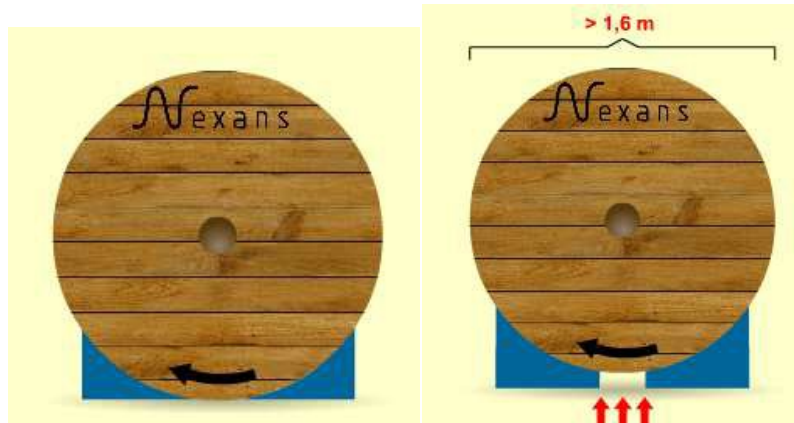
Wedges must be used to retain drums. Wedges must be positioned at flange edges and not between flanges. The use of stones are not recommended.

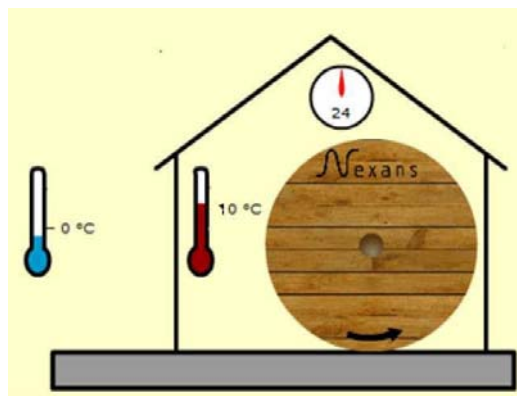
If the external temperature is below  $-5^{\circ}\text{C}$ , you should postpone cable pulling. If installation of cables is necessary, it is imperative to store them, before unreeling, in warmed room above  $+10^{\circ}\text{C}$  for at least 24 hours. Unreeling has to be done within 2 hours using a slow and regular speed (around 20m/minute) without shock.

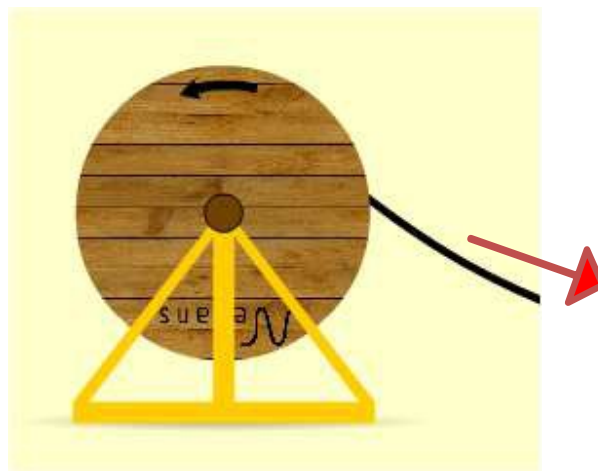
It should be noted that when pulling the cable off the drum, the arrow (painted on the flange of the drum) will point in the opposite direction to the rotation of the drum. This is an expected practice.

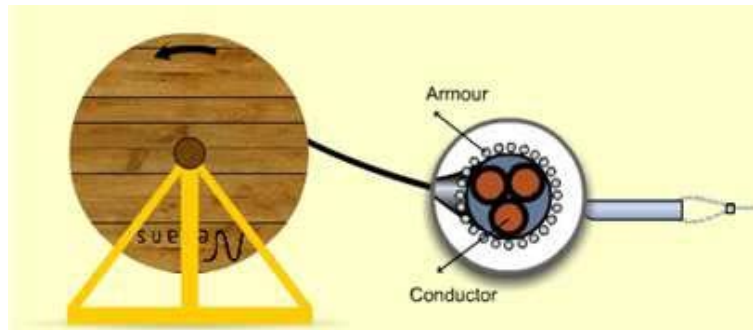
Cable ends will be protected by end caps or by pulling eyes. For longer lengths of cable (perhaps over 800 m) or for large conductor sizes (over 630 mm<sup>2</sup>), Nexans recommends the use of pulling eyes fixed to the main conductors of the cable. Pulling long and heavy cables by pulling socks can lead to cable or

The end caps and pulling eyes prevent moisture from entering the end of the cable and it is necessary to inspect the condition of the end cap or pulling eye when accessing the cable ends before the installation.

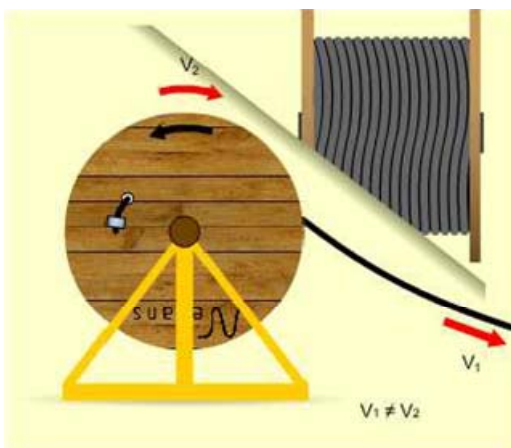
*Fixed Cable End – Creepage occurs*

The inside end of the cable has a tendency to creep through the hole in the flange when the drum is revolved in the opposite direction to that originally employed when winding the cable onto it. This tendency cannot be prevented. The amount of creepage depends on the length of the cable on the drum, the size of the cable and the number of times the drum is revolved. The accumulated slack due to unwinding long lengths of cable may amount to several metres. It can become extensive when the timber drums bolts have loosened or the timber has aged and shrinkage has taken place.

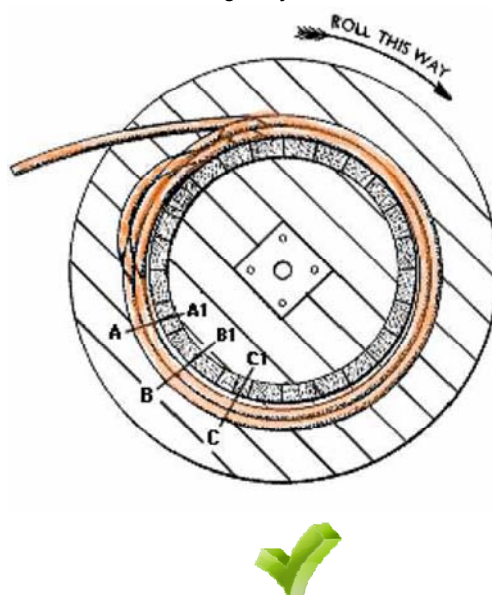
*Free Cable End – Extra length is formed outside*

To avoid creepage and sinuous shape on the barrel of the drum during paying off, the inner end of the cable on the drum flange should be free, not fixed to the drum.

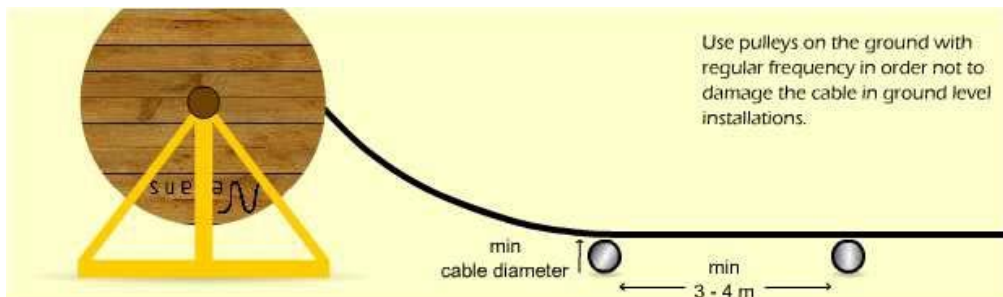
For long circuits, where long lengths or heavy cables are used, pulling tension calculations should be performed for each cable section. Pulling methodology should be prepared clearly detailing the drum position, position of winches or caterpushers, and the number and type of rollers to be employed. For direct buried installations, rollers should be used at 3-4 metre intervals, with more frequent rollers at bends

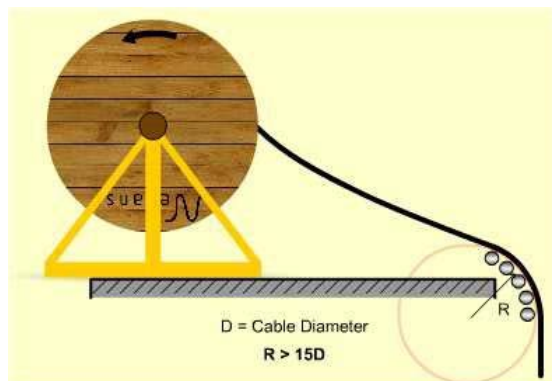
Ducting at cable bends must be selected so the curvature is not below the minimum bending radius during installation. When using rollers at cable changes in direction, it is recommended a number of rollers are used forming a radius that is larger than the minimum bending radius.
